Appendix: Fatigue Failure Modes of Aluminum Ultralight Rigid Wheelchairs

This article and any supplemental material should be cited as follows: Liu H, Pearlman J, Cooper R, Hong E, Wang H, Salatin B, Cooper RA. Evaluation of aluminum ultralight rigid wheelchairs versus other ultralight wheelchairs using ANSI/RESNA standards. J Rehabil Res Dev. 2010;47(5):441–56. DOI:10.1682/JRRD.2009.08.0137

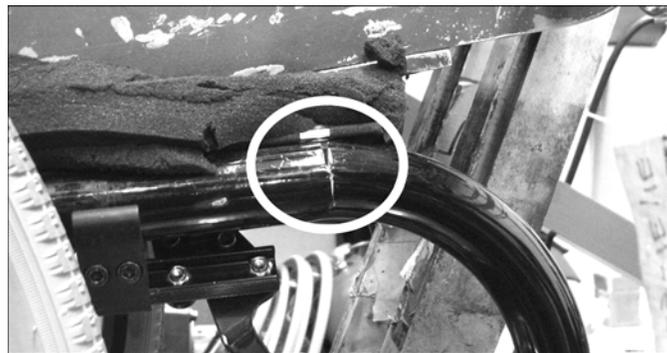
All TiLite AeroZ wheelchairs passed the fatigue standard. All the permanent frame failures were fractures at the first screw hole of the frame at the cantilever bend (**Appendix Figure 1**). Before the permanent frame failure occurred, wheelchairs had 2-5 minor failures, including footrests sliding down, screws loosened or fractured at the caster, seat pan, and rear wheel axles, and an aluminum seat rail fractured.

Appendix Figure 1. Frame Failure of a TiLite AeroZ wheelchair.

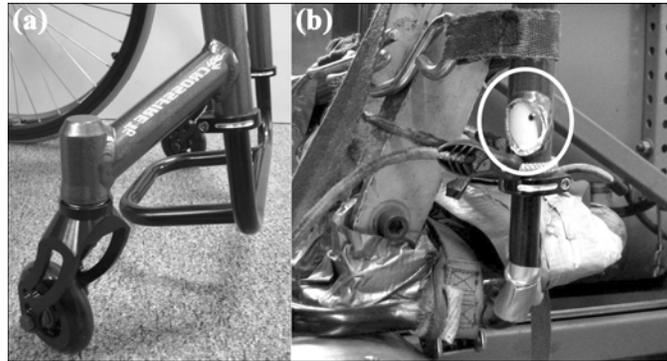
Two Invacare Crossfire wheelchairs had frame fractures at the welded areas at the caster tubes (**Appendix Figure 2**). One of them passed the fatigue standard. Before the caster tubes fractured, they had 1–2 minor failures, including footrests sliding down and one worn caster tire.

Appendix Figure 2. Caster tube failure of an Invacare Crossfire wheelchair. The left picture shows the original structure of the caster in relation to the footrest suspension tube. It was flipped horizontally to match the wheelchair orientation in the right picture. The circle in the right picture indicates the fracture surface where the caster was detached from the footrest suspension tube.

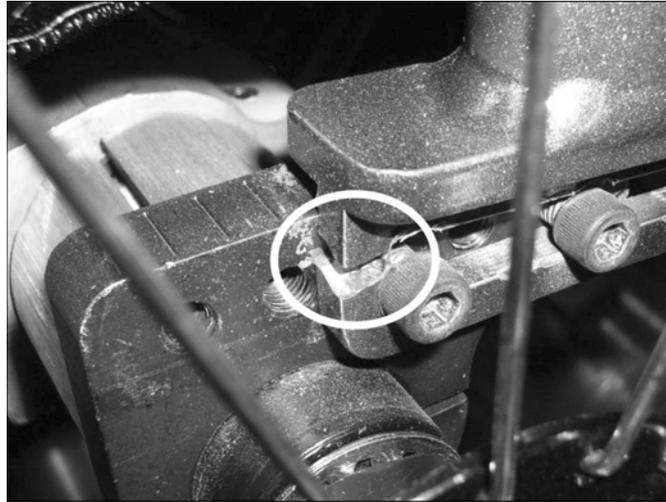
One Invacare Crossfire had a fracture at the camber tube support (**Appendix Figure 3**). This wheelchair did not pass the fatigue standard. At the completion of the test, it was noted that there were no washers between the socket screws and the camber tube supports. The camber tube supports were worn by the socket screws, and thus their strength was reduced. We checked the photographs of the wheelchair taken before starting any tests and realized that this chair did not have the washers installed by the manufacturer on both camber tube supports. This chair had one minor failure in that an axle bolt was loosened.

Appendix Figure 3. Camber tube support fracture of an Invacare Crossfire wheelchair. The circle indicates the fracture of the camber tube support.

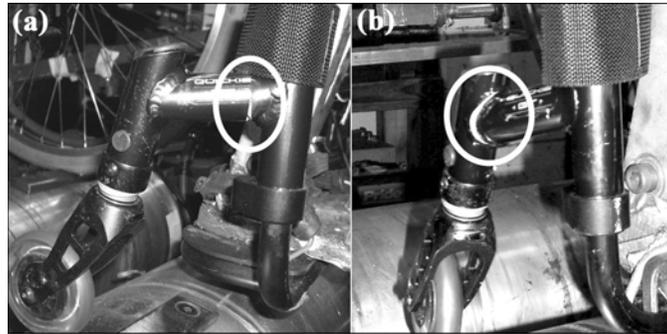
All of the Quickie GT wheelchairs passed the first iteration of the fatigue tests and thus the fatigue standard. During the second iteration of the fatigue testing, two Quickie GT wheelchairs fractured at weld areas on caster legs connected with the footrest suspension tube or the caster housing (**Appendix Figure 4**). One of them did not have any minor failures before the caster leg fracture. Another one had three minor failures including an axle bolt and the screw for backrest angle adjustment loosened coming out. The other Quickie GT had a backrest tube fracture at the screw hole for backrest angle adjustment (**Appendix Figure 5**). This chair had three minor failures, including the rear wheel axle shifting forward and a screw on the seat pan loosened.

Appendix Figure 4. Two Quickie GT wheelchairs had castor leg fractures around the welding areas connecting to the footrest suspension tube **(a)** and the castor housing **(b)**.

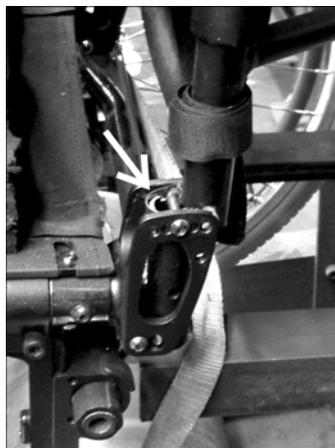
Appendix Figure 5. Quickie GT wheelchair had backrest tube fracture at the screw hole for backrest angle adjustment. The arrow indicates the fracture site on the backrest tube.

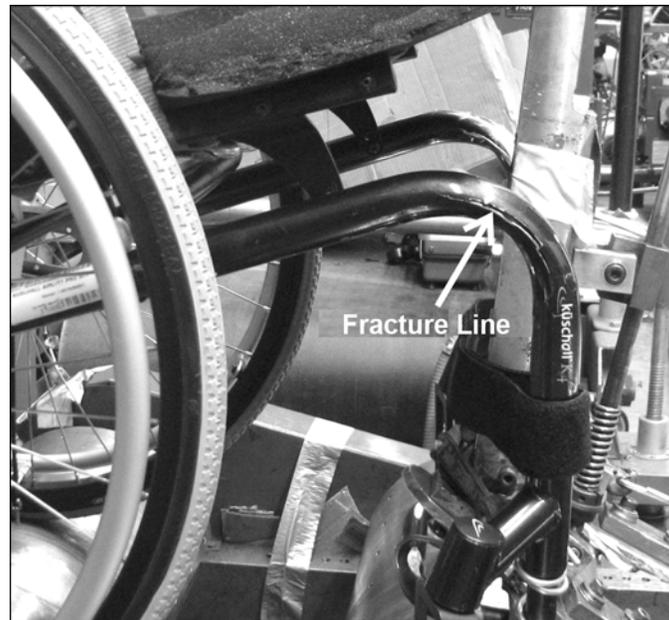
None of the Kuschall AirPro wheelchairs passed the fatigue standard. Two Kuschall AirPro buckled at the cantilever bends of their frames where the seat transitions into the footrest system **(Appendix Figure 6)**. One of them did not have minor failures before the frame failure.

Appendix Figure 6. Kuschall AirPro wheelchair buckled at the bend in the frame where the seat transitions into the foot-rest system.
