Investigation of wheelchair instability during transport in large accessible transit vehicles

Zdravko Salipur, MEng; Karen Frost, PhD; Gina Bertocci, PhD, PE*

Injury Risk Assessment and Prevention (iRAP) Laboratory, Mechanical Engineering Department, J. B. Speed School of Engineering, University of Louisville, Louisville, KY

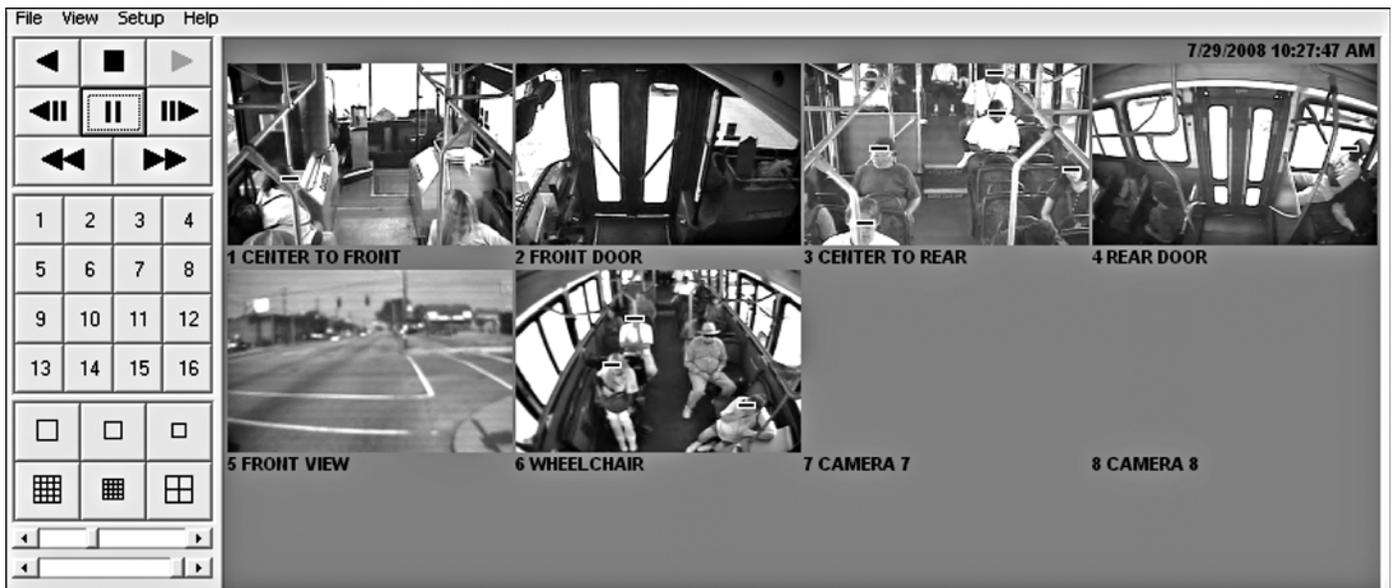
Figure 1.

In-vehicle six-camera large accessible transit vehicle (LATV) video surveillance system. This LATV was equipped with cameras to include views from front windshield, front and rear of interior, and front and rear doors, as well as wheelchair securement station.

securement station. We used the views of the wheelchair securement station and front of the LATV interior most often to observe events. Additional information describing the video collection process is published elsewhere [10].

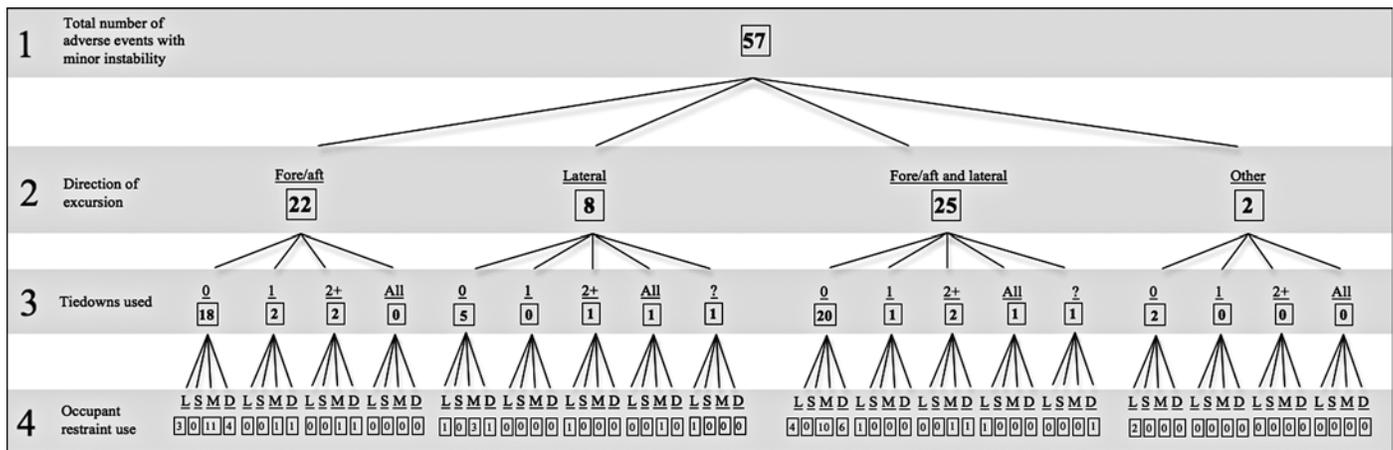
Figure 2. Tree-diagram showing direction of excursion, number of tiedowns used, and occupant restraint system use for 57 wheelchair instability events categorized as minor instability. D = occupant restraint system disuse, L = lap belt used, M = occupant restraint system misuse, S = shoulder belt used.

The tree-diagram in **Figure 2** characterizes the direction of excursion and WTORS configuration for each adverse event with minor instability. The second level of the tree diagram indicates the distribution based on direc-

tion of excursion. The third level indicates number of tie-downs used, and the fourth level indicates how the ORS was applied. Of the 57 events of minor instability, 25 (43.9%) involved a combination of fore/aft and lateral excursions of the wheelchair, while 22 (38.6%) involved fore/aft excursions only. We associated eight events (14.0%) with lateral excursions only and categorized two events (3.5%) as other wheelchair and/or wheelchair passenger instability (e.g., rear wheels of wheelchair lifting off ground, wheelchair passenger driving wheelchair out of securement station during LATV transit). For all sub-categories, the most frequent number of wheelchair tie-downs used was zero; 20 of 25 events (80%) involved fore/aft and lateral excursions, 18 of 22 events (82%) involved fore/aft excursions only, 7 of 8 events (88%) involved lateral excursions, and 2 of 2 events (100%) involved another instability type. Our findings also indicate minimal use of the ORS. The ORS was used to restrain the wheelchair-seated passenger in only 13 of

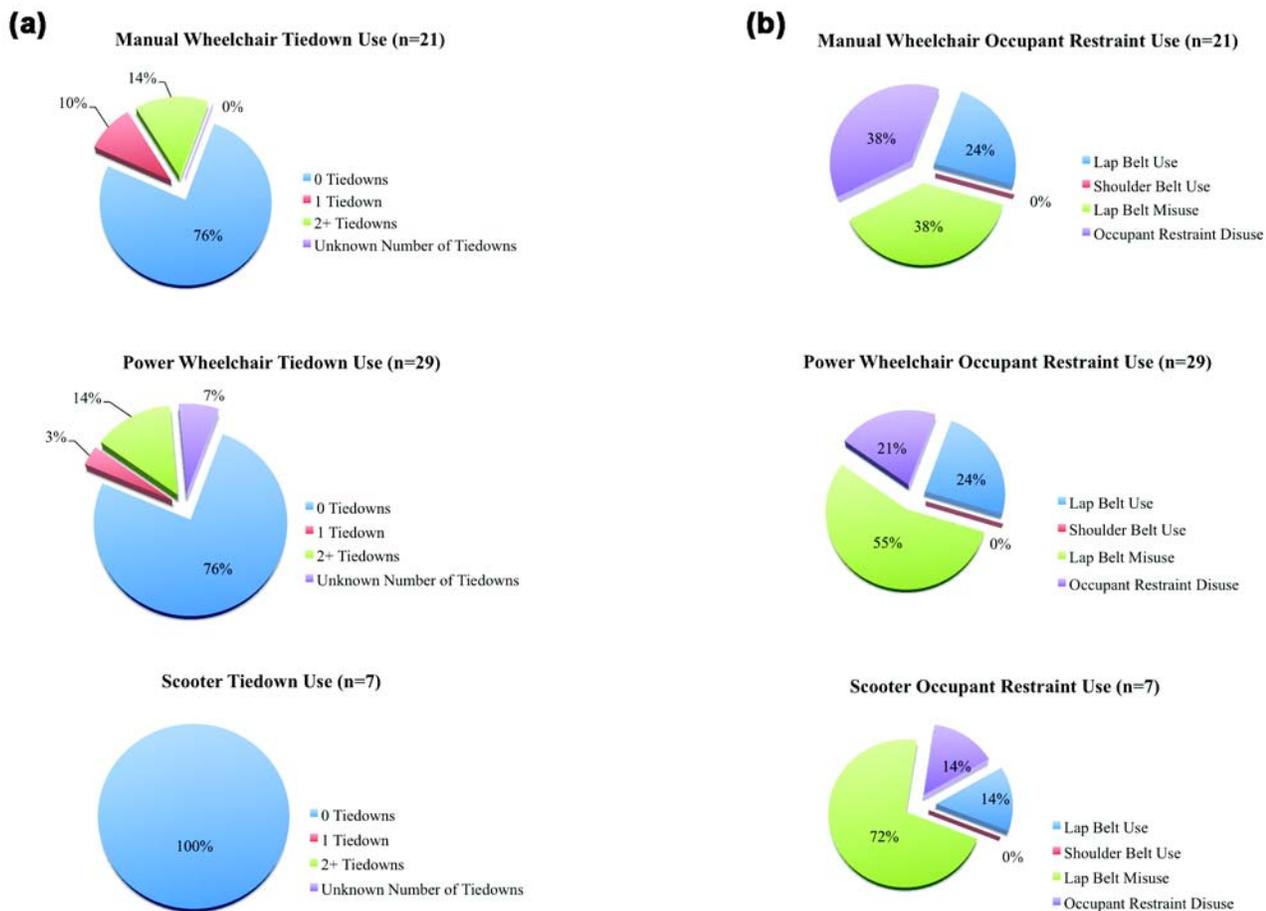
Figure 3. (a) Tiedown and (b) occupant restraint system configurations by wheelchair type in minor instability cases.

57 adverse events with minor instability (22.8%). The most frequently observed use of the ORS was the misuse of the WTORS to secure the wheelchair. Specifically, the lap belt was used to secure the wheelchair by routing the lap belt around the wheelchair seatback. We also determined the WTORS configurations by wheelchair type in all 57 cases of minor instability (Figure 3).

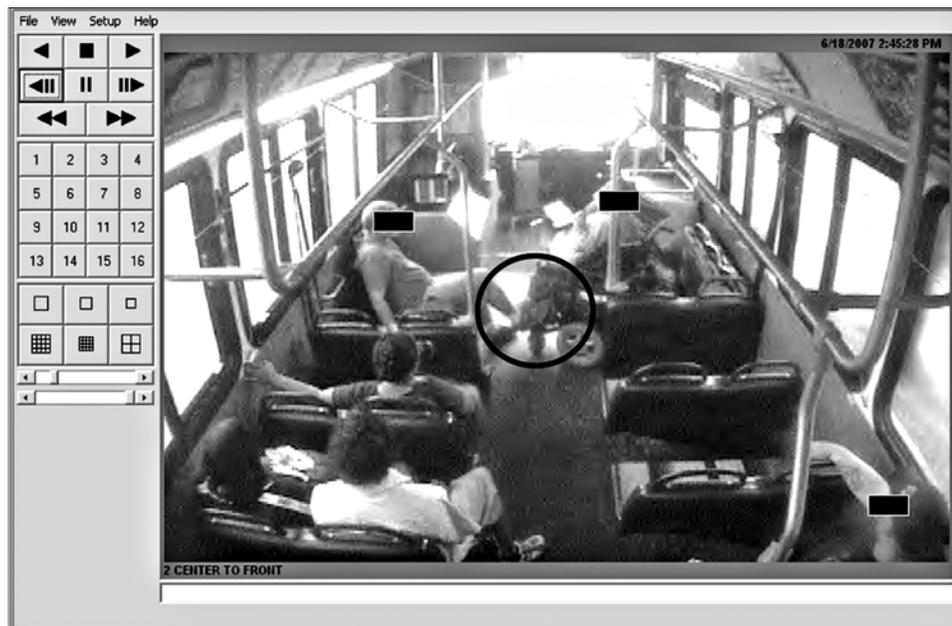
**Figure 4.**

The LATV appeared to be traveling at a constant forward velocity and was not turning, accelerating, or braking. Approximately 1 minute into transit, the power wheelchair appeared to rotate laterally into the aisle space (Figures 4 and 5). The wheelchair passenger remained seated in the wheelchair during this excursion. No non-wheelchair-using passengers were standing in the

excursion. It appeared that the wheelchair passenger engaged the controller, causing the wheelchair to rotate into the aisle space. The LATV operator stopped en route and manually repositioned the power wheelchair in the securement station. The operator spoke with the non-wheelchair-using passenger and then appeared to turn the power to the wheelchair off. The operator again did not secure the wheelchair using tiedowns, nor did she apply

Case 1: Unsecured power wheelchair enters aisle during routine large accessible transit vehicle (LATV) transit, while sitting non-wheelchair-using passenger lifts foot to prevent injury and limit power wheelchair movement. (View from LATV rear.)

Turning off the power to the wheelchair prior to transit may have prevented the power wheelchair from rotating into the aisle, even if the wheelchair passenger inadvertently struck the control joystick. Also, had all four tiedowns been applied properly (appropriate securement point locations with proper tiedown tension), the power wheelchair would likely not have been able to enter the aisle space.

Although no passengers were injured, the outcome may have been different if passengers were standing in the aisle during transit. This raises the point that proper WTORS application cannot only increase transportation safety for wheelchair passengers, but also increase safe transit for general ridership. Additionally, had the passenger sitting across the aisle from the securement station not attempted to prevent additional wheelchair excursion into the aisle, injuries to both individuals may have occurred.

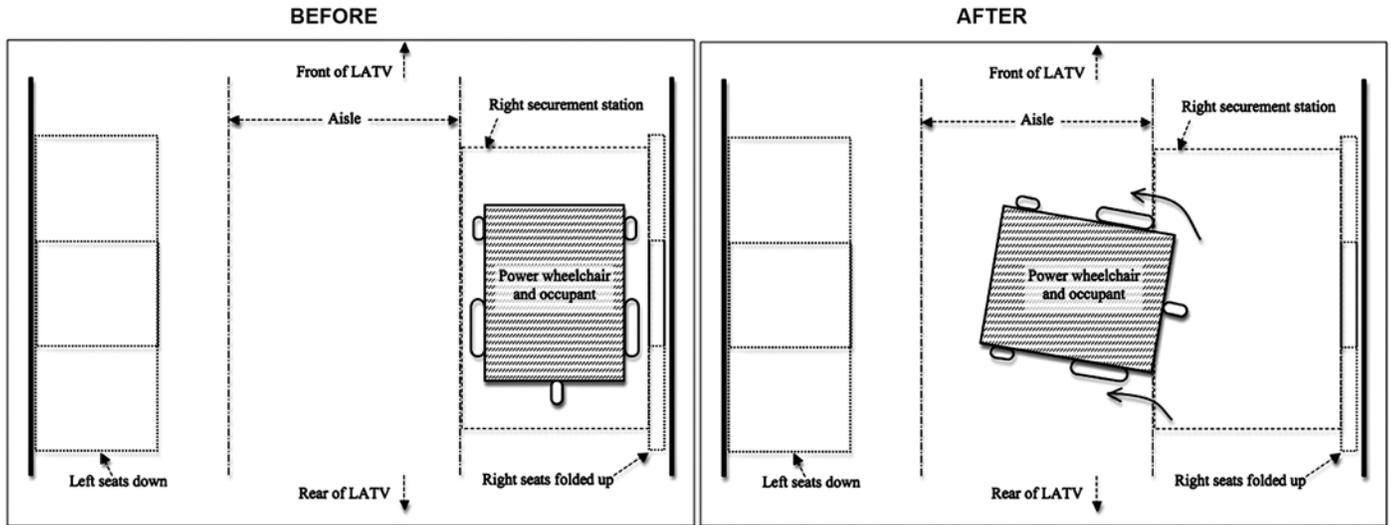
Figure 5.

Diagram showing unsecured power wheelchair rotating laterally into aisle during routine large accessible transit vehicle (LATV) transit (case 1).

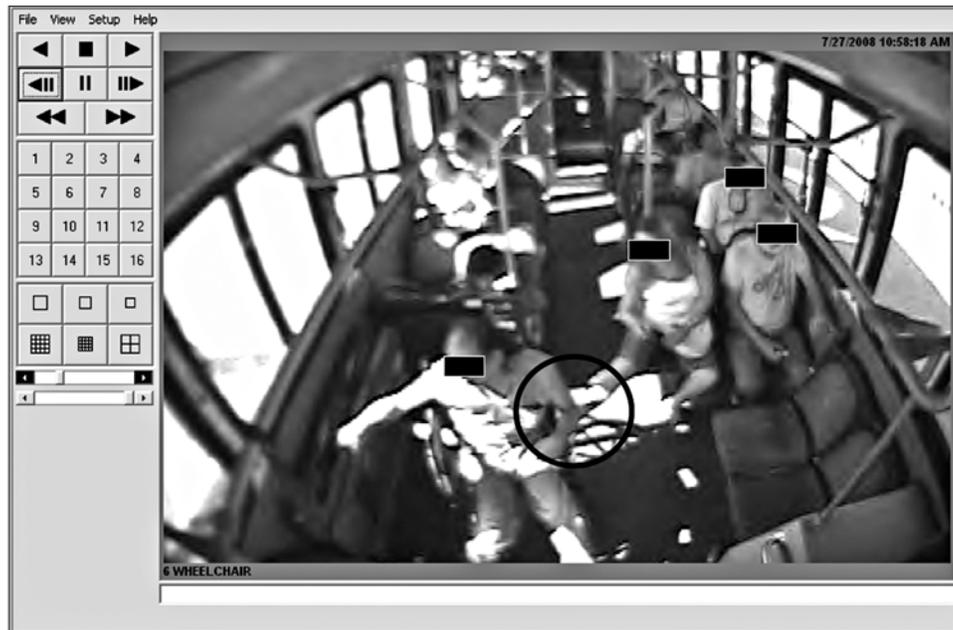
Figure 6.

Two minutes into transit, the LATV initiated a right turn. During the turn, the wheelchair rotated laterally into the aisle (**Figures 6 and 7**). As the wheelchair rotated into the aisle, the passenger grabbed the folding-seat under the window with his right arm and stabilized himself by placing both feet on the ground. A non-wheelchair-using passenger sitting across the aisle prevented additional excursion of the wheelchair into the aisle by extending her right leg and using her foot to push against the left rear wheel of the wheelchair. There were no passengers standing in the aisle and no passengers were injured. Immediately after the adverse event occurred, the LATV came to a stop and the wheelchair passenger repositioned

Case 2: Manual wheelchair passenger and wheelchair rotated into aisle as large accessible transit vehicle (LATV) performed right turn. Wheelchair passenger stabilized himself by placing both feet on floor and using his right arm to grab folding seat while non-wheelchair-using passenger used her foot to prevent additional lateral excursion of wheelchair. (View from LATV front.)

his wheelchair in the securement station. Once stopped, the LATV operator returned to the securement station and secured the wheelchair using all four tiedowns; he did not apply the shoulder belt or reapply the lap belt. No further instability occurred during the remainder of the trip.

As the manual wheelchair rotated into the aisle during a routine LATV right turn, the wheelchair passenger's ability to restrain himself using his limbs appeared to limit additional excursion into the aisle. Other wheelchair passengers may not have the same level of voluntary muscle control or the ability to restrain themselves as effectively, placing them at an increased risk for injury. Had the wheelchair been properly secured with tiedowns, the lateral wheelchair rotation into the aisle may have been prevented.

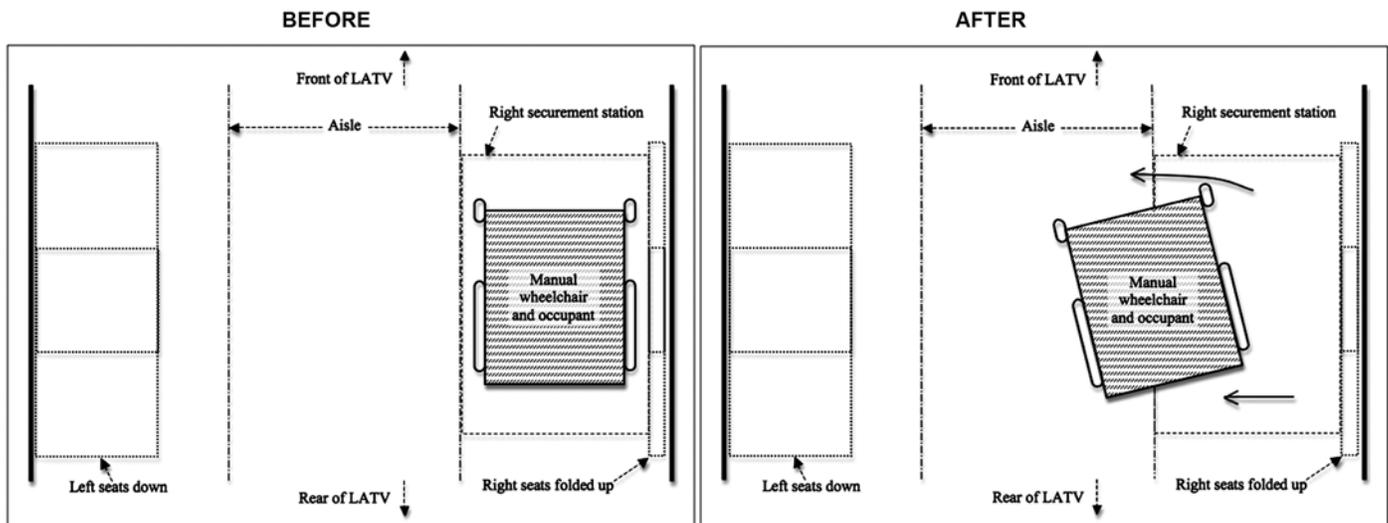
Figure 7.

Diagram showing manual wheelchair and wheelchair passenger rotating laterally into aisle during routine right turn (case 2). Note: Orientation of this diagram is 180° opposite of **Figure 6** camera view.

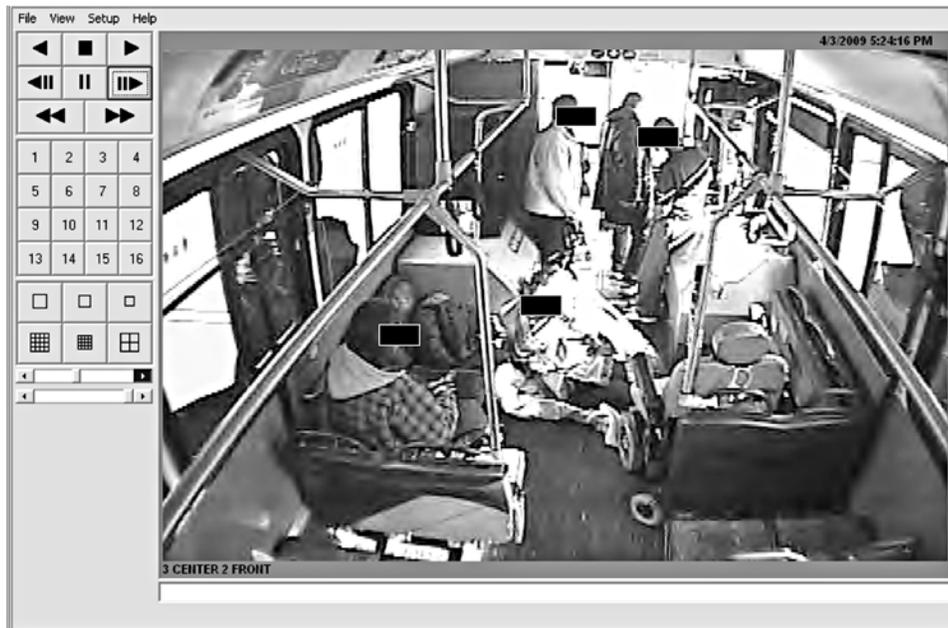
Figure 8.

The LATV was traveling in a forward direction at apparent routine speed relative to traffic. As it approached an intersection, the LATV appeared to slow down via normal braking, and the wheelchair passenger was ejected from her wheelchair into the aisle. Video observation reveals that the wheelchair remained in position within the securement station as the LATV reduced speed. The wheelchair passenger was ejected in a forward direction from her wheelchair (**Figures 8 and 9**). During ejection, the wheelchair passenger attempted to stabilize herself (stop her

forward motion) by using her right arm to prevent impact with the LATV bulkhead directly in front of the securement station. The passenger struck the bulkhead with her lower

limbs at knee level and fell laterally to the aisle floor. A non-wheelchair-using passenger sitting across the aisle attempted to restrain the wheelchair passenger with an

Case 3: Power wheelchair passenger ejected from wheelchair during normal large accessible transit vehicle (LATV) braking. Wheelchair passenger struck bulkhead in front of securement station and fell to floor complaining of fractured leg. (View from LATV rear.)

The power wheelchair passenger appeared to be using an undersized power wheelchair, equipped with captain seating. This type of seating system in general is not easily adjustable and is typically not designed for persons who may have special seating needs, such as bariat-

ric wheelchair users. This illustrates that wheelchair passenger safety on LATVs may not be limited to the issue of proper WTORS application because proper wheelchair prescription (through involvement of qualified therapists) is also important in wheelchair passenger safety. Using a properly applied ORS (lap and/or shoulder belt) would likely have prevented the wheelchair passenger's ejection from her power wheelchair. Finally, without the restraining assistance provided by the non-wheelchair-using passenger, the wheelchair passenger may have incurred additional injuries.

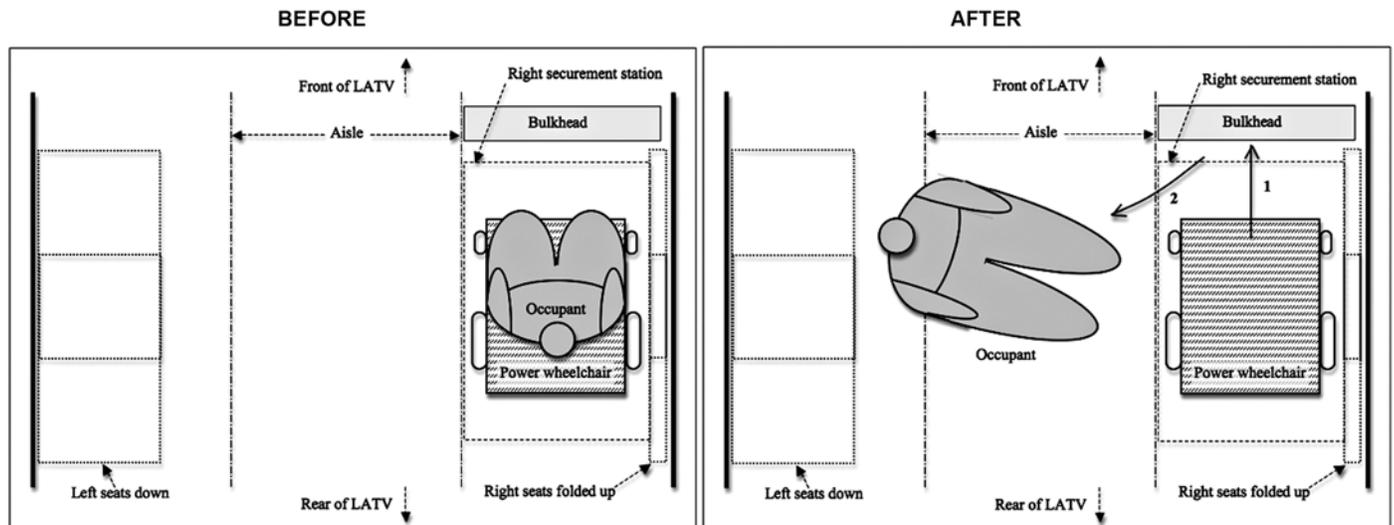
Figure 9.

Diagram showing power wheelchair passenger ejected from power wheelchair during apparent routine braking maneuver. During ejection, (1) wheelchair passenger struck large accessible transit vehicle (LATV) bulkhead directly in front of right securement station, and (2) then fell to aisle floor (case 3).
